TENSION CLAMP SO3.25

Type Test Report

Test standard: EN50483-3, 2009

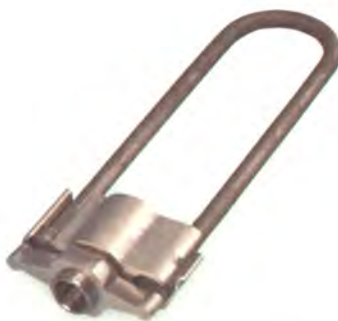
Picture 1: Tested clamp SO3.25

The clamp was visually looking the same as in the specification drawing.

All markings required by the standard were found:

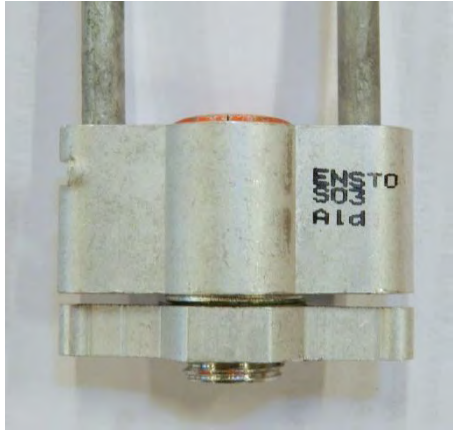
Picture 3: Markings on the clamp's body

ENSTO

SO3 (orange paint)

The cross section is marked on the cone of the clamp and is also indicated by a colour code (orange)

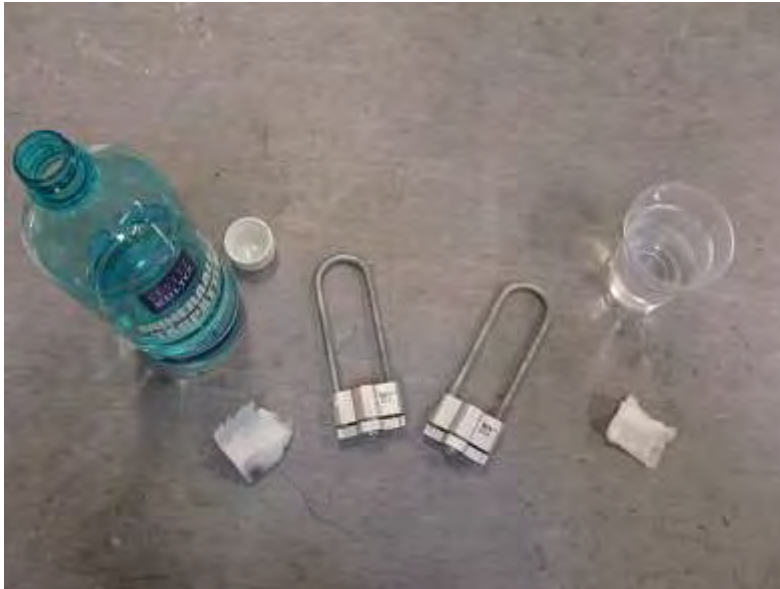
Picture 2: Samples after the test

The marking remained clear and was not affected at all by the rubbing.

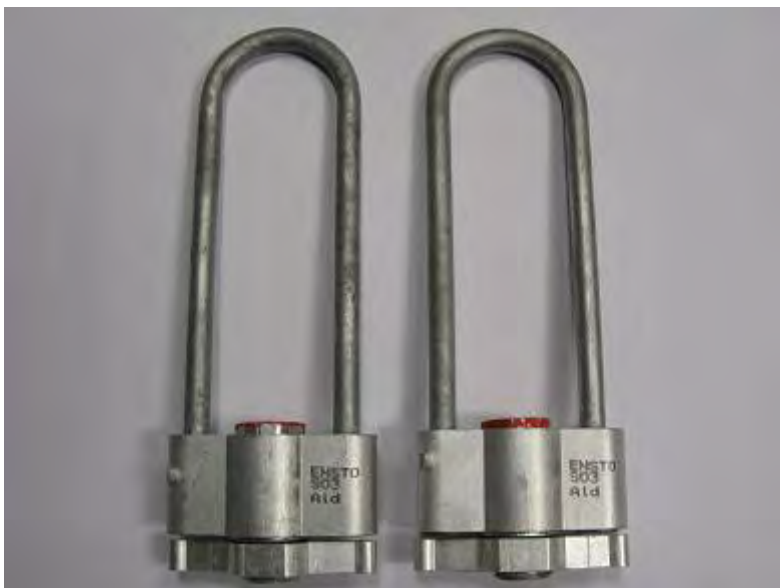
Picture 3: Samples after UV-test

No visual degradation could be noticed after the test and the markings on tension clamp were clearly legible.
