TENSION CLAMP SO28

Type Test Report

Test standard: EN50483-3, 2009

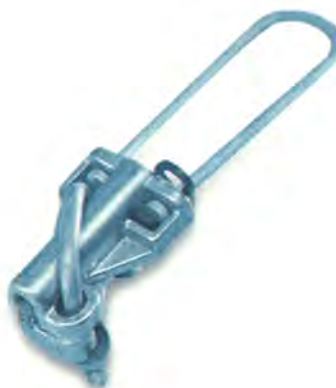
Picture 1: Tested clamp SO28.

The clamp was visually looking the same as in the specification drawing.

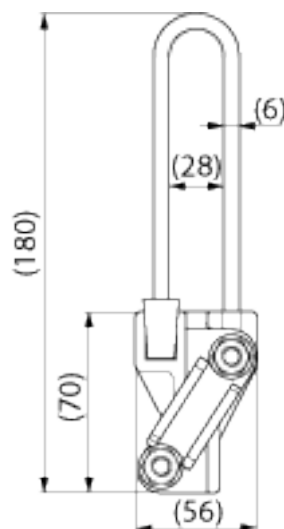
Distance	Requirement [mm]	Measured [mm]
Body height with bail	180	182,0
Body height	70	69,7
Body width	56	55,6
Bail diameter	6	6,0
Bail width	28	28,6

Picture 2: Specification drawing

All samples were within specification requirements. Clamp dimensions were within specification tolerances, see picture 2.

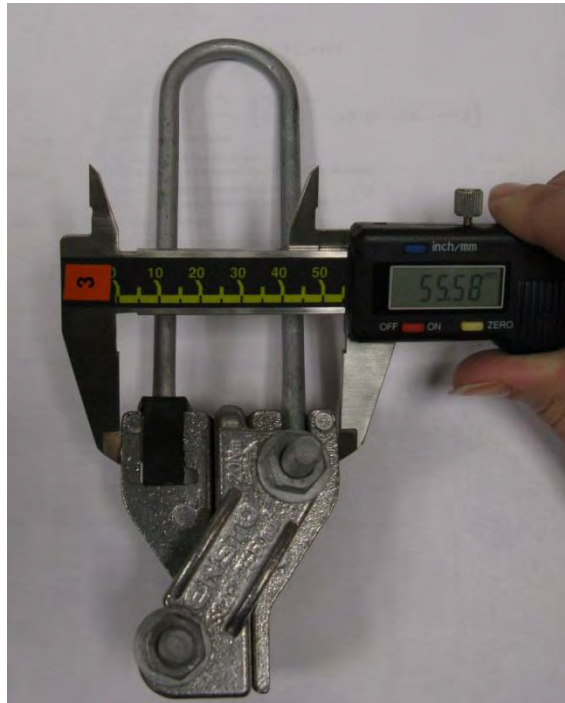
Picture 3: Clamp under the dimensional test

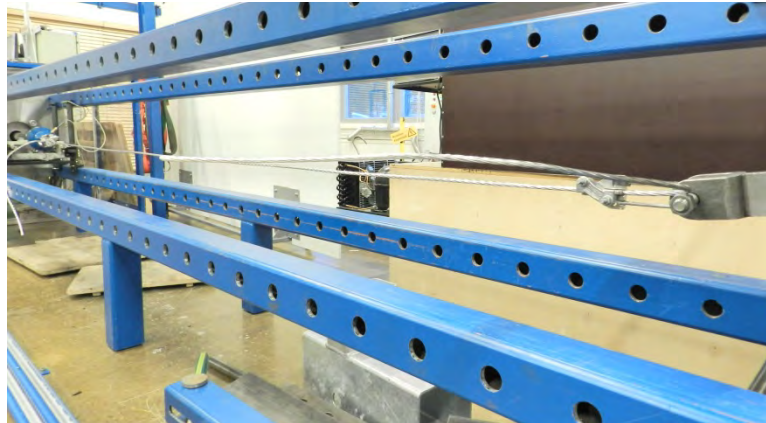
The clamps were installed to the messengers according to manufacturer instructions. The clamps were tested with messenger size 25 mm^2 and 50 mm^2 . The test assembly was installed into a horizontal test machine. First the load was increased to 80% of MBL of the messenger, next it was decreased to 20% of MBL of the messenger and the messenger was marked where it exits the clamp. Then the load was increased to 90% of MBL of the messenger and kept at this value for 60 seconds and the load was removed.

Picture 2: Test assembly

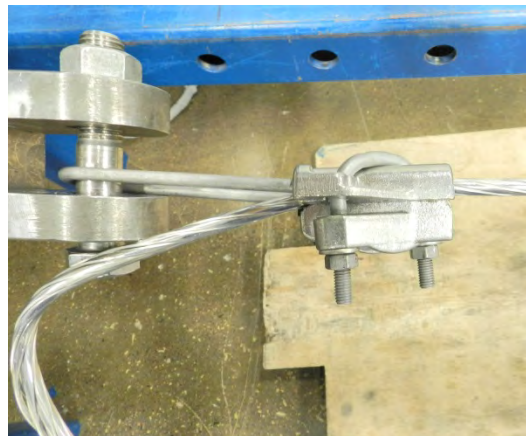
Picture 3: Clamp under test

Sample	MBL of conductor	80 % of MBL	20 % of MBL	90 % of MBL / 60 s	Slippage 1. 2. [mm]
50 mm ²	14,2	11,4	2,8	12,8	2 1
25mm ²	7,4	5,9	1,5	6,7	0 0

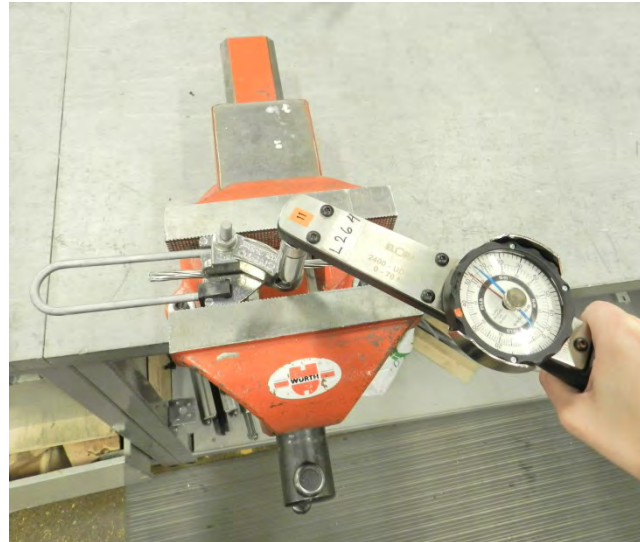
Two clamps were tested. The clamp was installed on to the messenger. The tightening torque was increased to 1,1 x the specified installation torque, 20 Nm x 1,1 = 22 Nm. The clamp was tightened and loosened ten times. After ten installations the clamp was tightened to the maximum torque value recommended by the bolt supplier, 24 Nm, which was lower than twice the specified installation torque value, 2 x 20 Nm = 40 Nm.

Picture 2: Test set up.

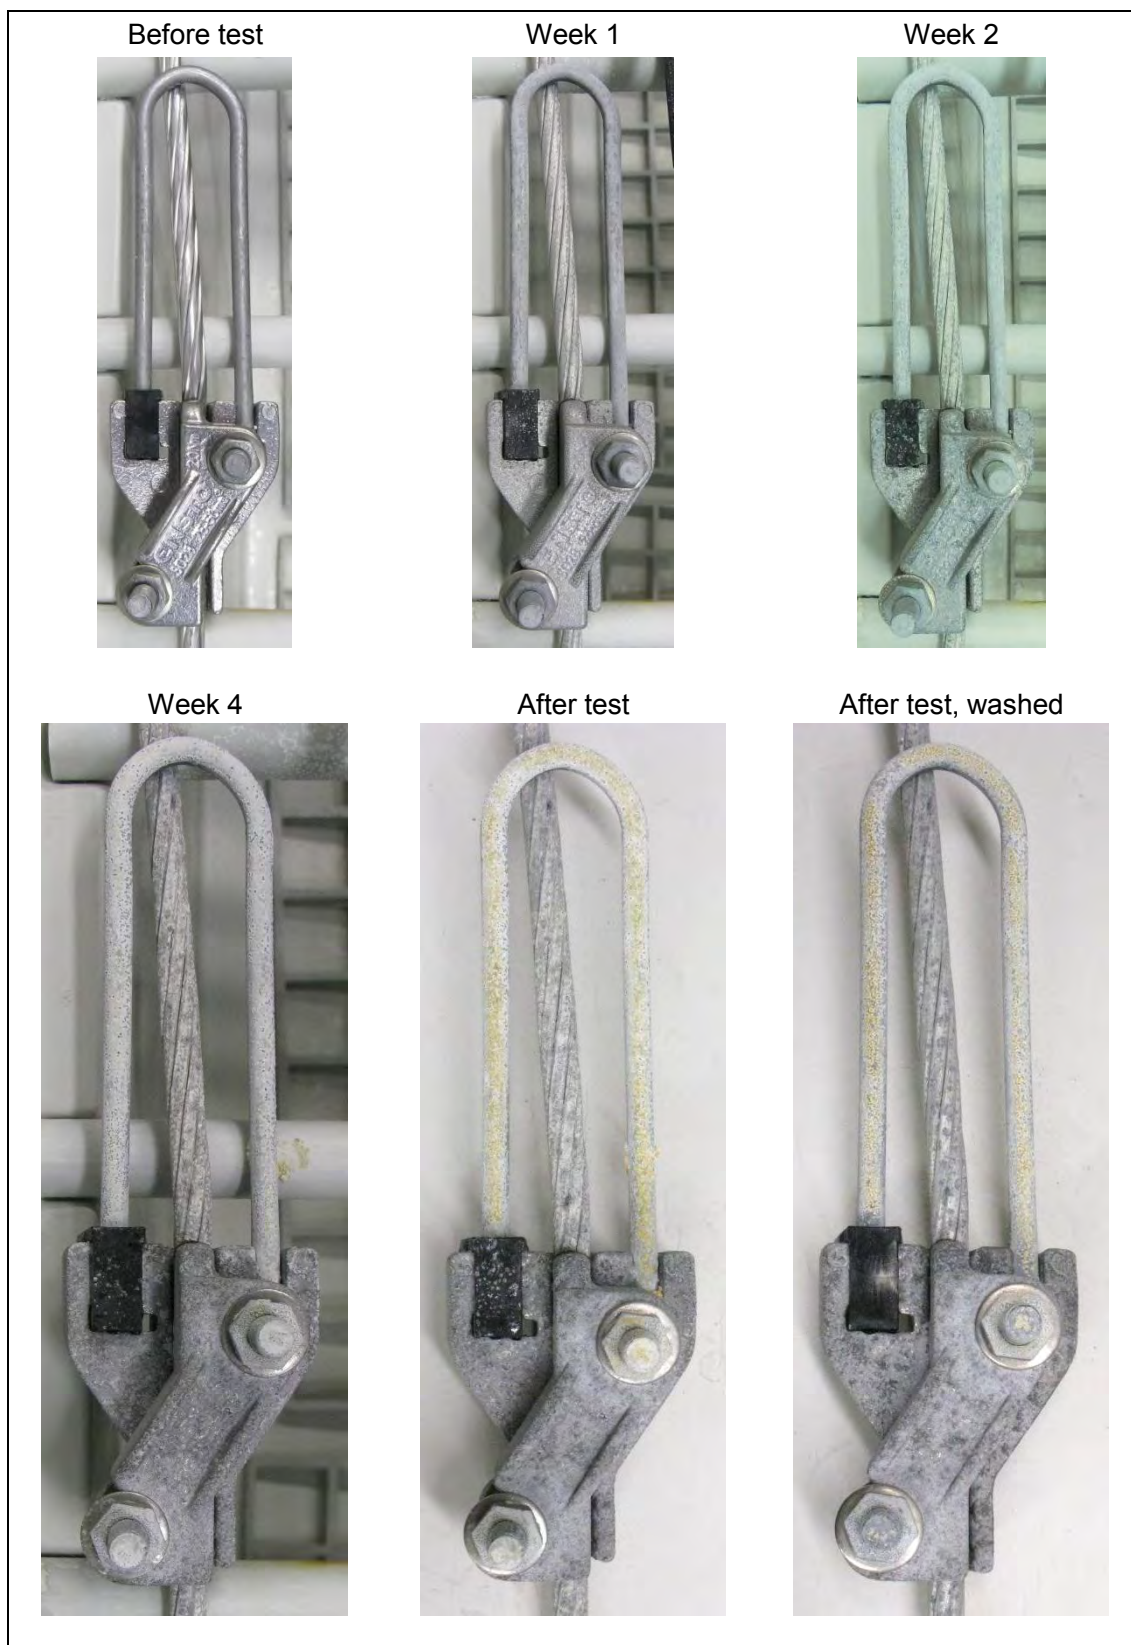
In the visual inspection substantial oxidation of the aluminium parts was visible on both samples but no trace of red rust. The identification marking was legible after additional cleaning of the tension clamp's surface. No damage occurred which could affect the correct function of the tension clamp in the corrosion ageing test or in the following tensile test.

Picture 3: SO28, sample 2

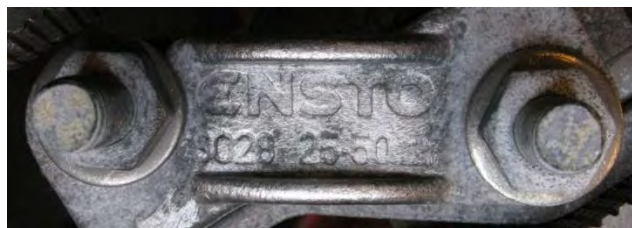
Picture 4: Identification marking after test

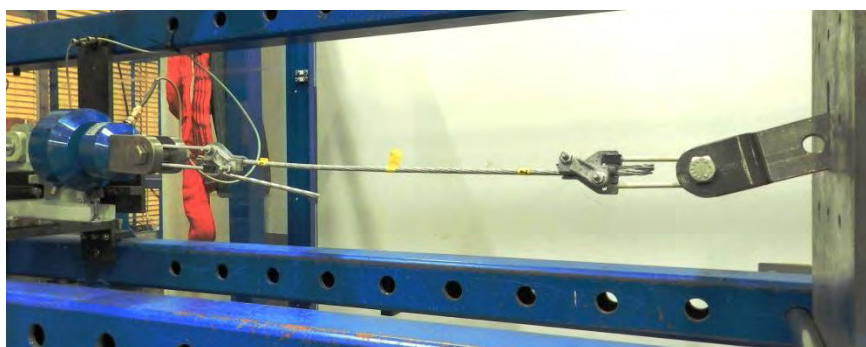
After the corrosion test the assembly was installed into a tensile test machine. A load was applied and increased until it reached 80 % of the MBL of the messenger after which it was reduced to 20 % of the MBL of the messenger. The messenger was then marked where it exits the clamp before the load was increased to 90 % of the MBL of the messenger and maintained for 60 seconds.

Picture 5: Tensile test setup

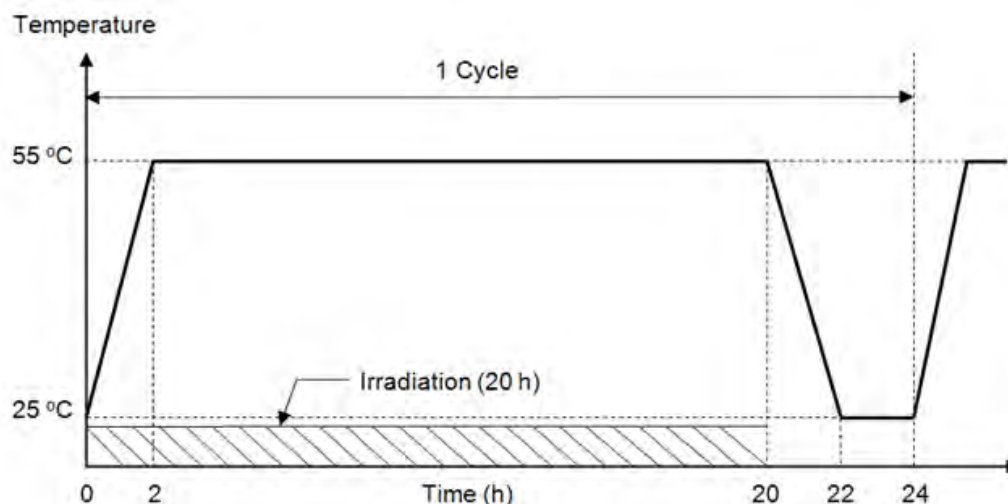
The test consists of 56 daily cycles (8 weeks). Each cycle consist of 20 h irradiation and 4 h darkness, fig 1. The temperature was maintained at $55 \pm 2 \text{ }^\circ\text{C}$ during the irradiation period and at $25 \pm 2 \text{ }^\circ\text{C}$ during the darkness period. The temperature was measured with a thermocouple in a point 40 mm below the measurement plane at half the distance between the specimen and the wall.

Figure 1: Temperature-radiation-time relationships

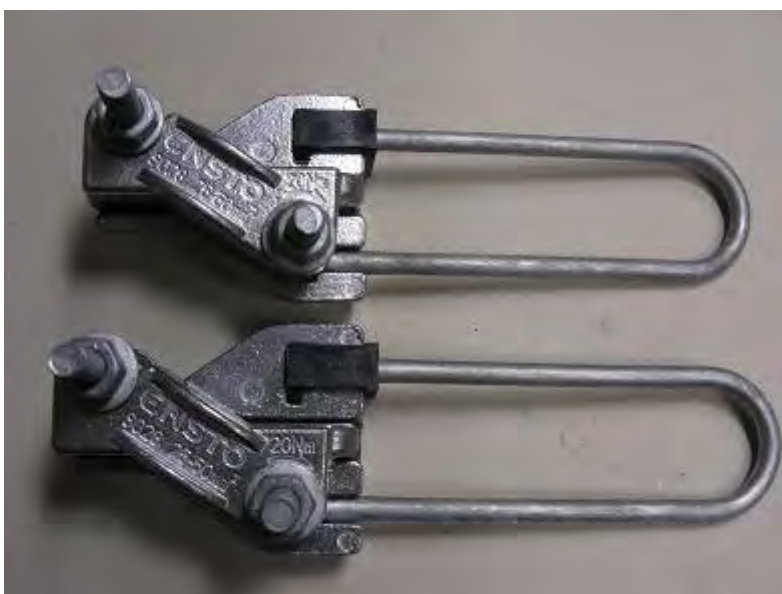
Picture 2: Samples before UV-test

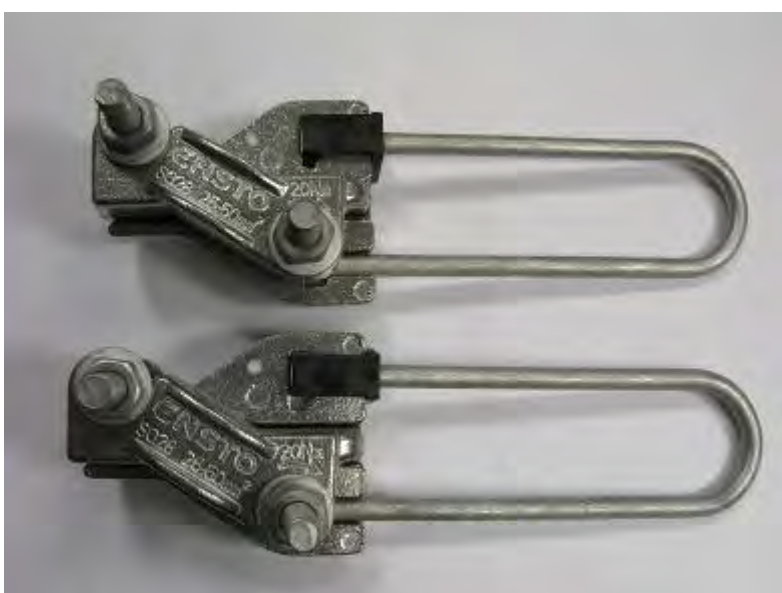
No visual degradation could be noticed after the test and the markings on tension clamp were clearly legible.

Picture 3: Samples after UV-test
